## Diagnostic strategies for fungal damage in Lasem's tropical heritage buildings

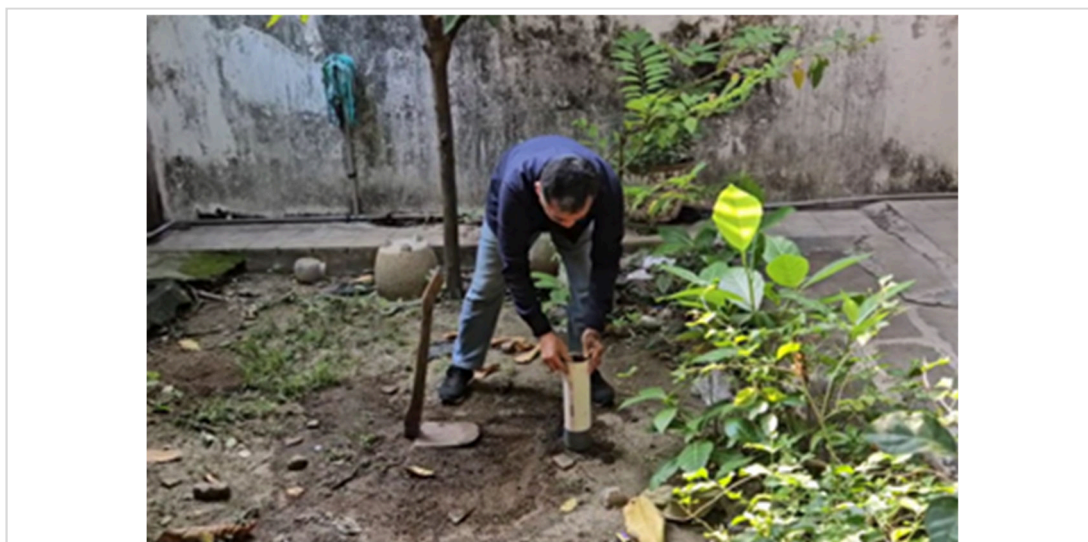
**Figure 1.** Samples of soil for the permeability test procedure

Identification of soil-moisture factors was conducted by integrating soil sampling (see figure 1), geotechnical soil-index testing based on K-values in cm/s, and GIS-based zonation to identify areas susceptible to moisture-related problems. Descriptive and inferential statistical analyses were applied to establish relationships between soil geology and moisture conditions.

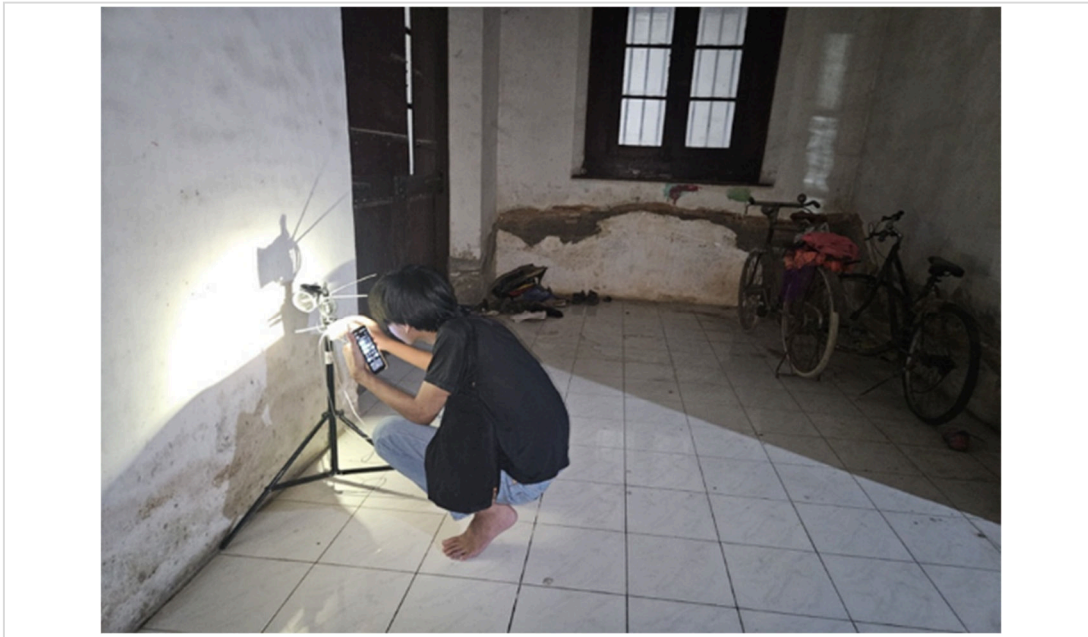
**Figure 2.** Microclimate observations on fungus-covered walls

Temperature (°C), RH (%), air velocity (m/s), and illuminance (lux) were continuously measured (Cao et al. 2021). Measurements were focused on a room in which visible fungal growth was present (figure 2). Sensors were positioned within the occupied zone and near the selected wall surface, as illustrated in figure 3. Wall-surface humidity was recorded three times daily, namely in the morning, at midday, and at night.
