## Evaluation of pedestrian paths feasibility in the area around Manggarai to support the transit-oriented development concept

Muhammad Faleri Febriyanto, Yohanes Karyadi Kusliansjah<sup>ID</sup>, Rumiati Rosaline Tobing\*<sup>ID</sup>

Department of Architecture, Faculty of Engineering, Universitas Katolik Parahyangan  
Jl. Ciumbuleuit, no. 94, Bandung, Indonesia

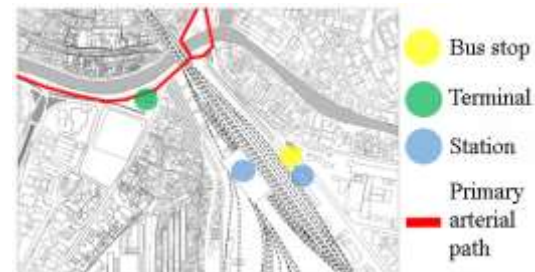
Figure 1. The location map of primary arterial roads

Roads such as Tambak and Sultan Agung street do not have direct access to the station, which should be via a secondary collector path. This type of primary arterial road has access to Manggarai Terminal (figures 1, 2, and 3).

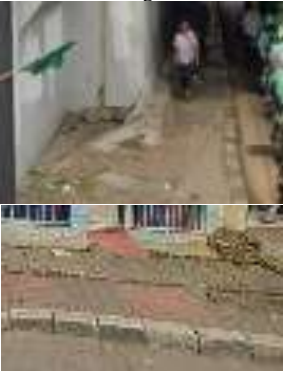
<p>Pedestrian path convenience.</p>	<ul style="list-style-type: none"> <li>Sidewalk height <math>\pm</math> 15 cm;</li> <li>The width of the sidewalks varies, at least 1.5 m;</li> <li>The ramp was in the middle of the sidewalk, not at the end or near an intersection.</li> </ul>	<p>Less comfortable, because:</p> <ul style="list-style-type: none"> <li>The sidewalk was only sufficient for walkers and wheelchairs;</li> <li>Easily accessible to normal people, difficult for the elderly and wheelchair users due to the wrong location of the ramp.</li> </ul>	<p>Did not meet the criteria for pedestrian comfort, and the standard width of the sidewalk.</p>	<ul style="list-style-type: none"> <li>Provide sidewalks according to standards, minimum width of 2 m;</li> <li>Provide a ramp as a start and end access to the sidewalk for wheelchair users and the elderly.</li> </ul>

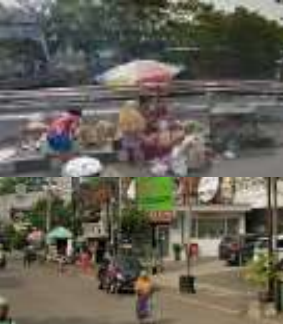
<p>Sidewalks were unobstructed and unbroken.</p>	<ul style="list-style-type: none"> <li>There were obstacles on the sidewalk</li> </ul>

<ul style="list-style-type: none"> <li>Street furniture becomes an obstacle</li> </ul>

<ul style="list-style-type: none"> <li>The sidewalks were not cut off</li> </ul>	<p>Even though the sidewalk was not cut off, it was taken over for other activities such as housing, trading, parking vehicles, etc.</p>	<p>Did not meet the criteria.</p>	<ul style="list-style-type: none"> <li>Freeing sidewalks from activities that hinder pedestrian circulation;</li> <li>Movable street furniture, therefore, it does not become a pedestrian barrier.</li> </ul>

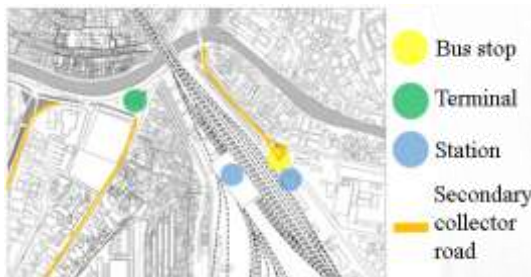
Figure 4. Map of secondary collector road location

These road types included North Manggarai, Minangkabau, and Sahardjo streets. North Manggarai street has direct access to the station, not to the Manggarai Terminal (figures 4, 5, and 6).

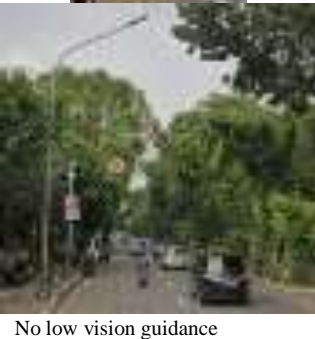
</li> <li>No low vision guidance

</li> </ul>	Incomplete, because there was lighting with no guide for low vision people.	Did not meet the requirements of pedestrian path completeness.	Need to add a low vision person guide.
Pedestrian path convenience.	<ul style="list-style-type: none"> <li>Sidewalk height <math>\pm</math> 15 cm;

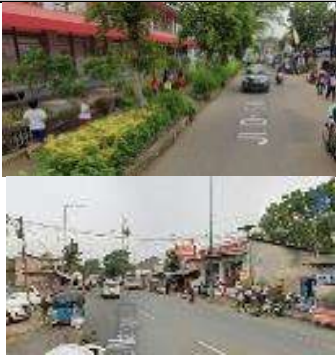
The facade of the building next to the sidewalk was active and alive, because it was a visual actived shop.	Met the criteria of being active and alive.	Can be maintainable.
Has shade and protection.	<p>There was a tree shade and dust cover on some of the sidewalks</p>	It does not meet the criteria because there were already shade trees and plants to protect it from dust, but it	Did not meet the criteria of shade and protection from dust.	<ul style="list-style-type: none"> <li>Adding shade trees and plants in places that still do not exist;</li> </ul>

was not evenly distributed in all places.		<ul style="list-style-type: none"> <li>Provide arcades in buildings on the edge of the sidewalk.</li> </ul>

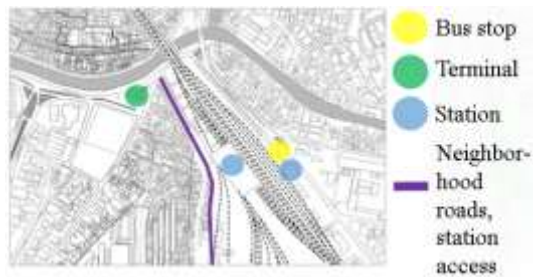
**Figure 7.** Map of neighborhood road location with access to stations

This type of road includes Dr. Saharjo 1 street which has direct access to the station, and does not have access to Manggarai Terminal (figures 7, 8, and 9).

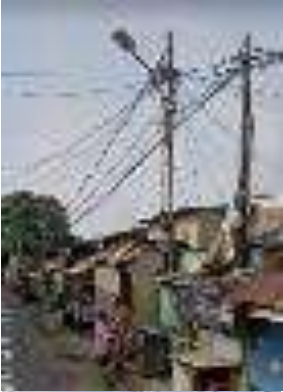
<p>Incomplete, because there was lighting but there was no guide for low vision people.</p>	Did not meet the criteria for the completeness of the pedestrian path.	Need to add a low vision person guide.
Pedestrian path convenience.	<ul style="list-style-type: none"> <li>No low vision guidance</li> <li>Sidewalk height <math>\pm</math> 15 cm;</li> <li>Sidewalk width <math>\pm</math> 2 m;</li> <li>There was no ramp for wheelchair access to the sidewalk.</li> </ul>

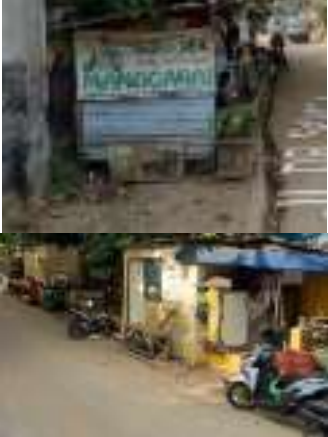
Pedestrian path criteria	Field conditions	Analysis	Conclusion conditions	Recommendation
Sidewalks were unobstructed and unbroken.	<ul style="list-style-type: none"> <li>The sidewalks were blocked and cut off, only 10 m long</li> </ul>

<p>there was no ramp.</p> <p>Sidewalks were cut off and taken over for other activities such as trading.</p>	Does not meet the criteria.	<ul style="list-style-type: none"> <li>Freeing sidewalks from activities that hinder pedestrian circulation;</li> <li>Continuing on the sidewalk.</li> </ul>
Pedestrian crossing.	There is no crossing the road facility.	Did not meet the criteria, because there was no crossing facilities.	Did not meet the criteria.	Providing zebra crossing especially in front of the Airport Train Station.
Active and living facades of buildings.	<p>There were stalls that were visually active.</p>

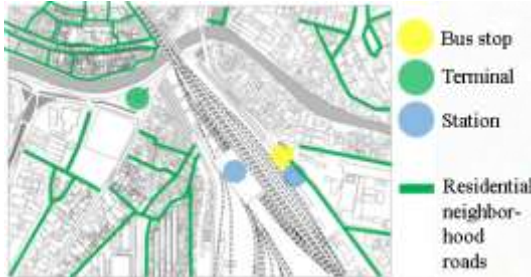
Figure 10. Map of neighborhood road locations with access to stations

Roads, such as Padang and Bukittinggi streets, etc., are located in a residential area, do not have access to stations or terminals (figures 10, 11, and 12).

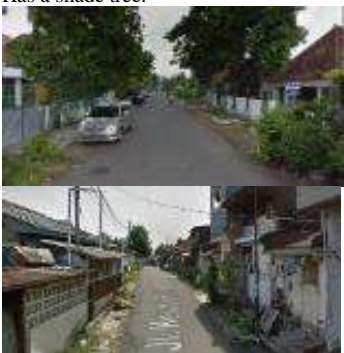
Pedestrian path criteria	Field conditions	Analysis	Conclusion conditions	Recommendation
Pedestrian crossing.	There was no crossing facilities.	Met the criteria because, there was no crossing facility, the flow of vehicles on this road was classified as low.	Met the criteria.	Maintainable.
Active and living facades of buildings.	The building has a set-back and was bordered by a house fence.	Not visually active because it was blocked by the house fence.	Did not meet the criteria of being active and alive.	Maintainable because: <ul style="list-style-type: none"> <li>This was a residential neighborhood road only passed by people living in the vicinity;</li> <li>To maintain the safety of the houses around this road and provide a green atmosphere.</li> </ul>
Has shade and protection.	Has a shade tree.

Did not have a dust filter plant.	Not meeting the shading and protective criteria, because: <ul style="list-style-type: none"> <li>Shade trees were not evenly distributed along the road;</li> <li>There was no dust filter and the flow of vehicles was relatively low. Only local residents pass on this road.</li> </ul>	Does not meet the criteria.	<ul style="list-style-type: none"> <li>Add a shade tree where it does not exist yet.</li> </ul>
