Adaptive reuse approach toward changes in the visual character of conservation buildings

A case study of Semarang Gallery

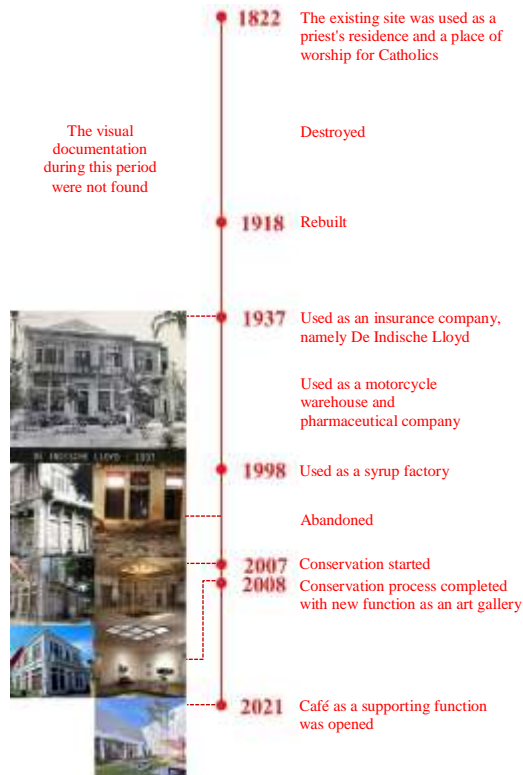
Figure 1. Timeline of the journey in using Semarang gallery's existing building from pre to post-conservation with a new function as an art gallery and cafe

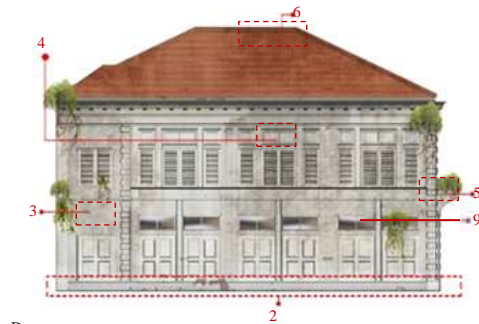
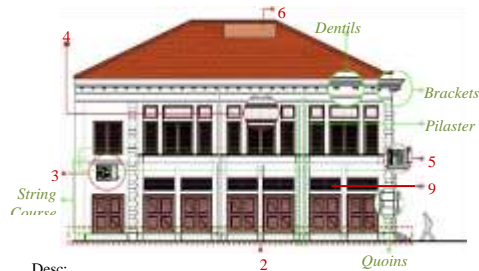
(c)
 Side view of existing building condition before conservation

Desc: Components on the facade experiencing the impact of new additions

(d)
 Side view of the current condition after conservation become Semarang Gallery

Desc:
 ■ The aesthetic significance of the typical Spanish Colonial architectural style
 ■ The impact of the new addition to defining function changes:
 2. Increasing the height of the ground floor by 1 m
 3. Placing the outdoor air conditioner on the facade
 4. The back of the wall panel structure is visible from the glass boven window on the facade
 5. Replacing the existing wall fence with a decorative iron texture one
 6. Replacing the existing clay roof tile with a clear glass texture

Figure 3. (c) Side view of existing building condition before conservation. (d) Side view of the current condition after conservation as a result of the new additions

Figures 2, 3, and 4 show that the changes as an art gallery and café require new additions to the facade of the Semarang Gallery because the initial condition was unsatisfactory. First, additional signage proportional to the size of the opening door, serving as a form of limited intervention, was discovered at the main and side entrances to the art gallery and café, respectively, to define its new functions. Second, the ground floor was increased by 1 m in height to prevent chemical damage due to tidal water. Third, the existing wall fence on the balcony was replaced with a similar texture and decorative model to maintain the rhythm of the facade appearance. Therefore, at first glance, it does not appear like new elements were added. Fourth, an outdoor AC installation is placed on the facade to eliminate the distinctiveness of the exterior visual character because it causes pollution (Soeroso 2007). On the contrary, its placement on the facade led to the installation of air conditioners in the interior features of the art gallery. Fifth, the back of the wall panel structure is visible from the glass boven windows on the facade. This forms a strategic intervention to define the new functions of an art gallery.

Figures 2, 3, and 4 prove that the new additions to the facade do not cause a significant change in the exterior visual characters. The preservation architects failed to change the facade rhythm of the Semarang Gallery, which has a distinctive aesthetic significance similar to the Spanish Colonial architectural style. The new additions tend to increase its functional values, which are important for art galleries and cafes' performance by adding signage and increasing the ground floor height. However, the new additions have a contrasting impact on the interior features, such as causing visual pollution on the facade, thereby eliminating the uniqueness of its exterior.

Figures 3 and 4 show that changes to the roof structure have an insignificant impact on the exterior visual character. This is because it is invisible from the main facade or front view and is only felt in the interior features, as shown in figures 3 and 4. These changes are due to the impact of the clear glass texture used to replace the clay type on the existing roof tile perpendicular to the skylight and void areas. The replacement is a strategic intervention important

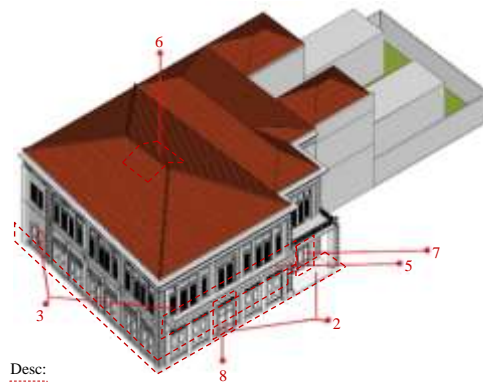
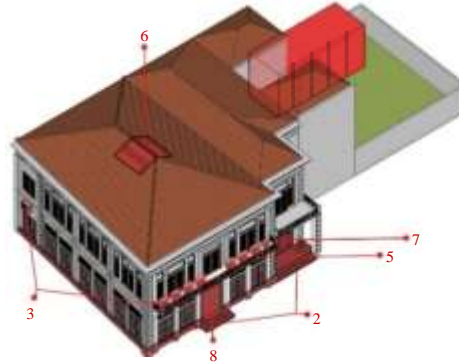
(e)
 Axonometry of the existing facade condition before conservation

Desc: Components on the facade experiencing the impact of new additions

(f)
 Axonometry of facade current condition after conservation become Semarang Gallery

Desc:
 ■ The impact of the new addition to defining function changes:
 2. Increasing the height of the ground floor by 1 m
 3. Placing the outdoor air conditioner on the facade
 5. Replacing the existing wall fence with a decorative iron texture one
 6. Replacing the existing clay roof tile with a clear glass texture
 7. Replacing the existing wooden door at the main entrance with a new door with clear glass texture
 8. Added new door openings for circulation loading dock exhibition with aluminum textured rolling doors

Figure 4. (e) Axonometry of the existing facade condition before conservation. (f) Axonometry of the current facade condition after conservation as a result of the new additions

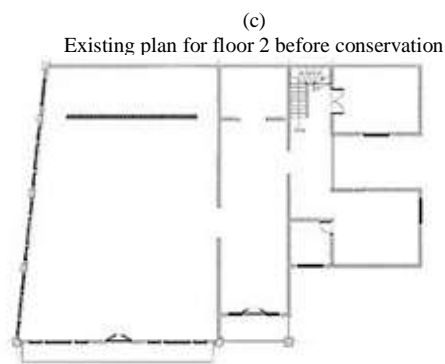
Figure 6. (c) Existing plan for floor 2 before conservation. (d) The latest plan for floor 2 after conservation as a result of the new addition

Figures 5 and 6 show that the impact of these changes on the order of space were identified by analyzing the existing pre and post-conservation current plan. The preservation architects changed

Consequently, the new spaces are grouped into 4 zones. This includes a public zone comprising the main and side entrances, foyer, lobby, café, corridor, toilet, and outdoor spaces. The semi-public zone consists of an art gallery, while that of the private includes a warehouse, electrical mechanical, and service rooms, as well as the manager's bedroom. The last is the semi-private zone which includes the living, and management rooms, balcony, and guest bedroom.

The visitors' movements were usually from the art gallery to the café or vice versa. Figures 5 and 6 show that changes in the order of spaces caused a significant impact on the interior visual characters because the sequence or narrative flow of visitors' movements becomes non-linear or irregular.

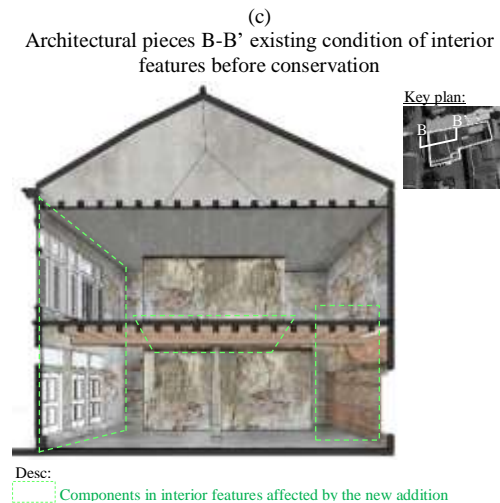
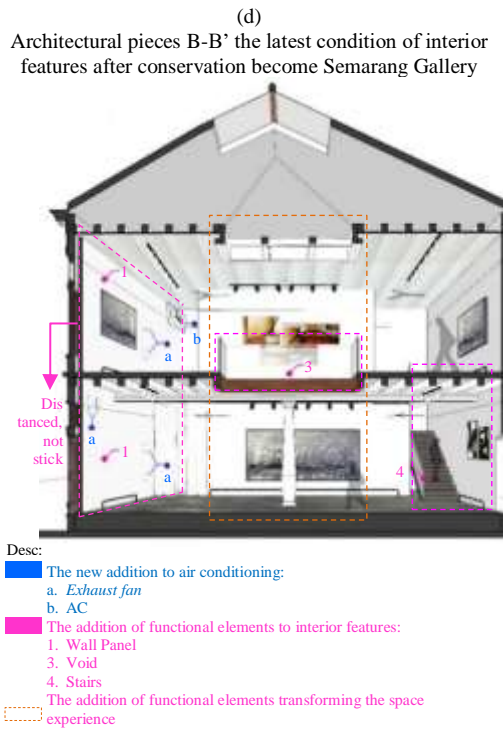
Figure 8. (c) Architectural pieces B-B' existing condition of interior features before conservation. (d) Architectural pieces B-B' latest condition of interior features after conservation as a result of new additions

Figures 7 and 8 show certain changes in the internal features, which significantly impacted the interior visual character. The addition of functional elements creates a contrasting effect changing the space scale, thereby causing it to become double volume (Sari 2005). These functional elements consist of wall partitions, panels, stairs, and voids, as a form of strategic intervention to define an art gallery.

The interior location of the functional elements is based on certain considerations, which refers to the gigantic scale of the building while paying attention to the existing interior structural layout. Therefore, it is proportional to exhibit 2 and 3-dimensional works of art. Figures 7 and 8 shows that the addition of wall panel elements is built with an unattached structure, distanced from the existing wall therefore it tends to be dismantled without leaving a trace. The addition of a wall partition element distracts the visitors as well as the exhibition loading dock. The stairs and void elements are strategically placed at an easy-to-see location to attract visitors, namely in the room corner and between the 2 existing columns, which are right at the center of the art gallery. These interventions create a transparent link between the 1st and 2nd floors and the artworks on display, thereby increasing the interior features' functional values after conservation. Figures 7 and 8 also show the installations of air conditioners and exhaust fans placed on the wall panels.

Figures 8 and 9 show that changes in the exposed structure caused a significant impact on the interior visual characters. The existing teak wood beam shape changes and seems incomplete due to the impact of the void addition that was excluded in the building's initial plan.

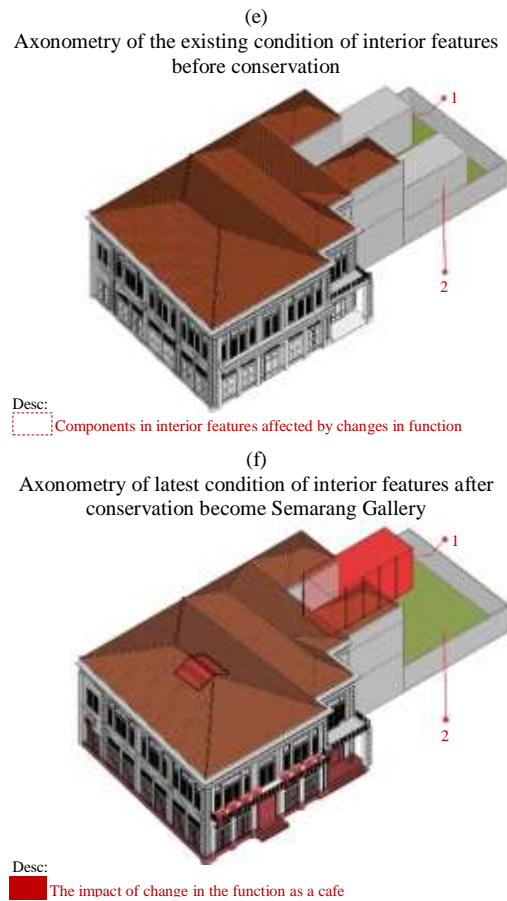
Figure 9. (e) Axonometry of the existing condition of interior features before conservation. (f) Axonometry of latest condition of interior features after conservation as a result of new additions

Figure 9 number 1 shows that structures contradicting the cultural significance were demolished. It is currently being converted into an outdoor space, enjoyed by visitors, and relevant for its performance. Figure 9 number 2 shows a newly erected room. In addition, rescue and physical repairs were carried out using concrete. The structures were currently converted into a café, thereby resembling a new building in the Semarang Gallery (Lucchi 2020).

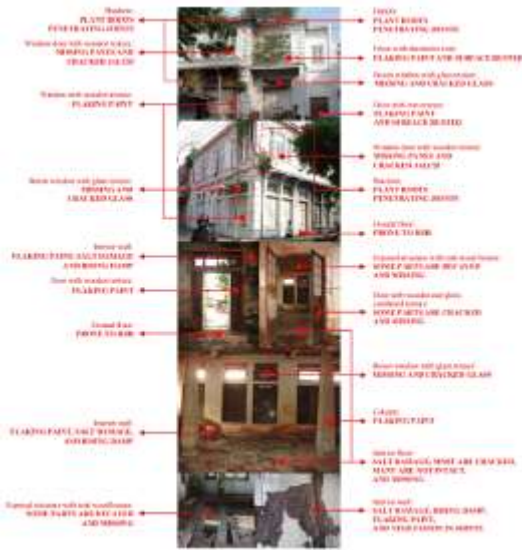
Figure 12. Significant changes in the existing exterior and interior textures due to the various types of damage before conservation

Figure 12 shows that the existing texture of Semarang Gallery has undergone significant changes even before conservation. However, during that period, several changes in function lacked a preservation basis. The previous owners handled the existing building like an ordinary one. The traces are evident in the visual documentation, which shows that significant changes in the existing texture occurred because of the various damages. This was due to the fact that the building was abandoned after improper utilization and poor maintenance before conservation.

Figures 12, 13, and 14 show that the adaptive reuse approach causes significant changes to the visual character at close range. Changes in the quality of the existing texture of Semarang Gallery, including its installation with the new one, produced a harmonious contrast combination

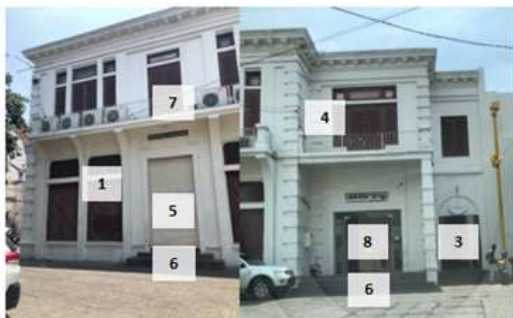
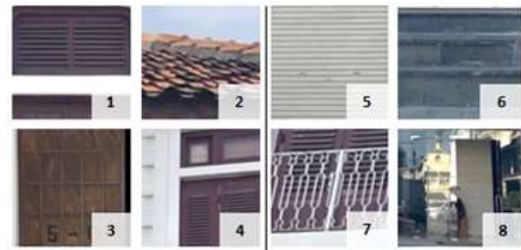
Maintained existing textures Added new textures
Figure 13. The latest texture of the main facade after conservation

Figure 13 shows that even though there are changes to the new functions due to the adaptive reuse approach, during maintenance, the preservation architects fixed the existing damaged textures in accordance with conservation principles. This was realized by maintaining the existing texture that was still intact, including restoring its original condition, which became its specialty. The figure shows the textural restoration of the existing white-painted external walls (figure 13 number 4). The preservation and restoration of the metal texture on the side entrance door (figure 13 number 3) and also the clay texture on the existing roof tile (figure 13 number 2). Although, the contrasting effect of the selected color type in respect to the modern wood paint seems unable to reveal its original texture in the existing outer doors and windows (figure 13 numbers 1 and 4). Figures 13 and 14 also show that the preservation architects tried to add new compatible textures with the existing ones. Therefore, both new and existing textures are expressive in respect to time. These textures are found on the main external facade. This includes the aluminum texture on the rolling door for the exhibition loading dock (figure 13 number 5). Andesite stone texture on the main entrance steps and the door (see figure 13 number 6). The texture of iron is painted white on the decorative fence (figure 13 number 7) and that of clear glass on the new main entrance door (figure 13 number 8).

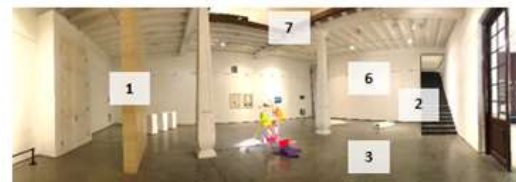
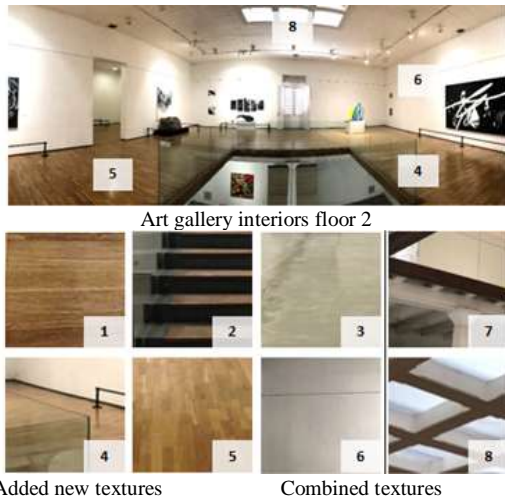
Art gallery interiors floor 1

Figure 14. The latest interior texture after conservation

Furthermore, new and modern textures are also found in the art gallery interiors, such as marble ceramic on the partition wall (figure 14 number 1), a combination of exposed concrete, wood, and clear glass on the stairs (figure 14 number 2), epoxy exposed concrete on the first floor (figure 14 number 3), clear glass on railing voids (figure 14 number 4), parquet wood on the second floor (figure 14 number 5), and also the white painted MDF board on the wall panels (figure 14 number 6). Figure 14 also shows that the preservation architects tried to combine new and modern textures with existing ones that are still in good condition into a recently exposed structural system found in art gallery interiors during the conservation process. It is evident in the new clear glass texture combined with the existing concrete structure and teak wood painted in white and brown to form a structural system in the form of voids (figure 14 number 7). Furthermore, it is also shown in the new frosted glass texture combined with teak wood. The remaining beams of the existing exposed structure are painted white and transformed into a new structural system in the form of skylights (figure 14 number 8). The clear glass texture dominates the exterior facade and the art gallery interior. This is because it is considered the most appropriate new texture added to clarify the old ones (Lestari and Alhamdani 2014).
