## Assessment of fire resistance performance of composite bamboo shear walls

Lily Tambunan<sup>1\*</sup>, Luis Felipe Lopez<sup>2</sup>, Andry Widyowijatnoko<sup>1</sup>, Yulianto Sulisty Nugroho<sup>3</sup>

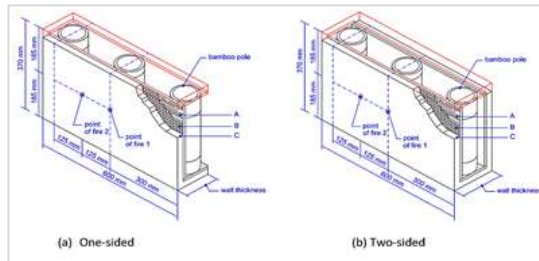
(A = Flattened bamboo; B = Chicken wire; C = Mortar)  
**Figure 1.** Construction of specimen

arranged parallel to each other. The specimen length is 600 mm, height 300 mm, and thickness 150 mm. Bamboo stalks and bracing were covered with mortar (1PC : 3sand) with a thickness of 25-35 mm. There are two variations of specimens with different kinds of mortar covering using flattened bamboo and chicken wire/metal lath.: one-sided (code 1P-1, 1P-2) and two-sided (code 2P-1, 2P-2). The specimen was kept for 2-3 weeks until the mortar was completely dry. The detailed construction of the model is seen in figure 1.

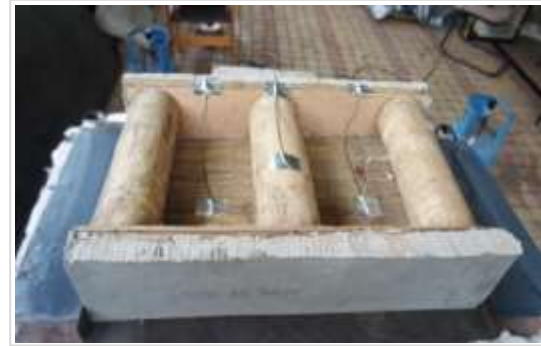
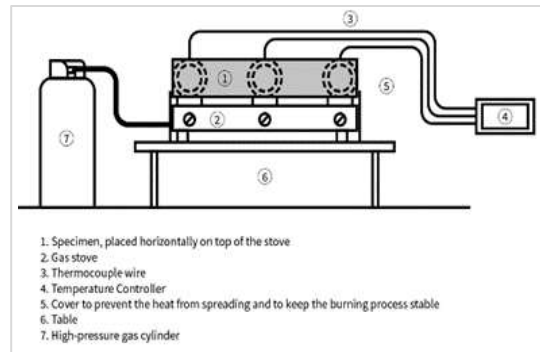
**Figure 2.** Position of thermocouples on the specimen (a) and position of the specimen during the test (b)

Two gas stoves with a maximum heat of 800°C and two 12 kg gas cylinders were used as test furnaces. Six thermocouples were used to read the temperature of the specimen and the furnace. The specimen was placed in the furnace at a horizontal position (figure 2). Software LabVIEW Measurement ver. 0.92 was used to read the data from thermocouples. A digital thermometer was also used to identify specific points in the specimen that could have a higher temperature than other points. The variety of burning temperatures ranges from 200 °C to 800 °C. The temperature was recorded every 5 minutes, and every change in the specimen was recorded, e.g., fire, water, or crack emission. The test is stopped when the temperature of the unexposed side of the specimen exceeds 100°C or the maximum burning time of 120 minutes, respectively.

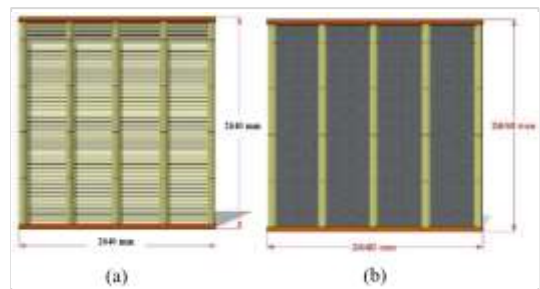
**Figure 3.** One-sided specimen (a), two-sided specimen (b)

Two specimens measuring 2640 mm x 2640 mm made of flattened bamboo covered with mortar with a thickness of 20-25 mm, on one-sided (M1) and two-sided (M2), are used (figure 3).

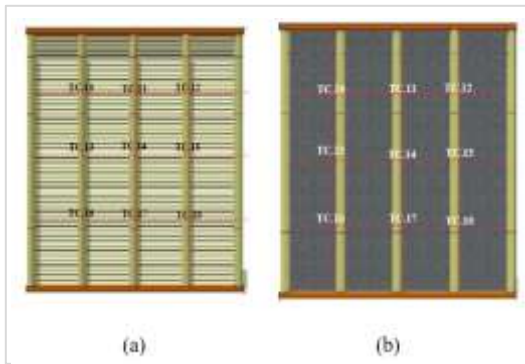
**Figure 4.** The position of the thermocouple on the unexposed side of the specimen M1 (a) and specimen M2 (b)

The furnace temperature was measured using nine thermocouples (TC1-TC9) evenly distributed in the furnace. The back-surface temperature of the specimen was measured using nine thermocouples (TC10-TC18) mounted on the not exposed to fire surface (figure 4).

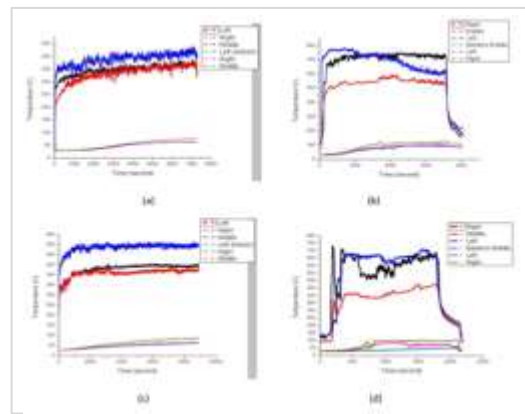
**Figure 5.** Time-temperature curves result of pre-test for specimen (a) 1P-1, (b) 1P-2, (c) 2P-1, and (d) 2P-2

Test results of the pre-test stage for all specimens are shown in figure 5 and table 1.

From the results in table 1, it is known that in terms of time, the higher the furnace temperature, the shorter the time required to increase the temperature of the two specimens to exceed  $100\text{ }^{\circ}\text{C}$ . The burning time of specimen 1P-1 is longer than that of specimen 1P-2, with a lower combustion temperature of 1P-1 than specimen 1P-2. The burning time of specimen 2P-1 is shorter than that of specimen 2P-2, with a higher burning temperature of specimen 2P-1 than specimen 2P-2. At the end of the combustion, the temperature of specimen 2P-1 is higher than that

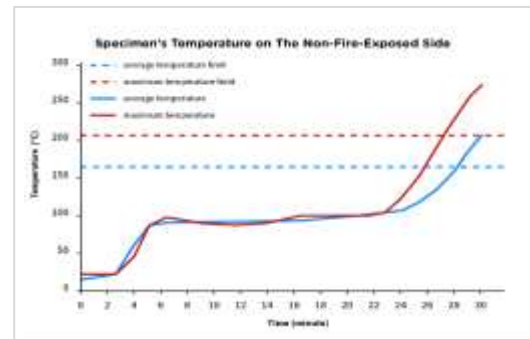
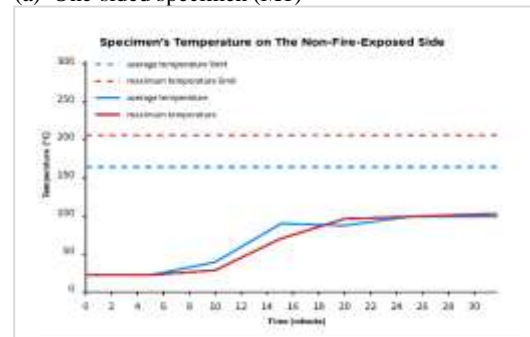
(a) One-sided specimen (M1)

(b) Two-sided specimen (M2)

**Figure 6.** Time-temperature curves result of standardized test for one-sided and two-sided specimen

The standardized test result for the one-sided specimen (M1) and two-sided specimen (M2) is shown in figure 6 and table 3.

Like the pre-test, the standardized test results showed that the specimen temperature increased with increasing furnace temperature and combustion time. The M1 specimen test was carried out for 32 minutes, where until the 32nd minute, the average upper surface temperature of the test object was 94.2 °C, not exceeding the average temperature limit value (163.1 °C) and not exceeding the maximum temperature limit value (203.1 °C). After 32 minutes of testing, the test object was damaged by fire cracking, and the test was stopped. Thus, it was determined that the value of the insulation resistance and integration of the test object was 30 minutes (according to the value of the five-minute measurement interval). The M2 specimen test was carried out for 119 minutes, where at the 110th minute, the average back surface temperature of the test object (154.4 °C) had not exceeded the average temperature limit value (164.1 °C). However, the temperature at one point of the thermocouple reached 221.5 °C, which exceeded the maximum temperature limit value (204.1 °C). Thus, the value of the insulation resistance of the M2 specimen is 105 minutes (according to the value of the five-minute measurement interval). After 119 minutes of testing, the specimen was damaged by fire cracking, and the test was stopped. Thus, the value of the integrity criterion is 115 minutes (according to the value of the five-minute measurement interval). Table 3 shows that the insulation and integration level of the M1 specimen is lower than that of the M2 specimen. Thus, the level of fire resistance of M2 specimens is higher than that of M1.

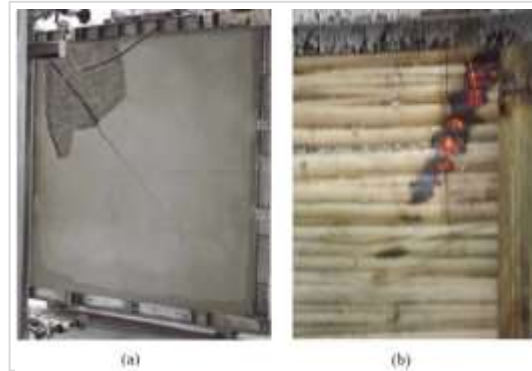
**Figure 7.** Mortar condition of specimen M1 after the test. Cracks and peels on the fire-exposed side (a) and a close-up of parts on the non-fire-exposed side (b)

The condition of flattened bamboo in the M1 specimen was partially burnt due to penetrating cracks. Meanwhile, at the same minute, on the M2 specimen, there was no fine crack, and the condition of flattened bamboo and bamboo polish on the side not exposed to fire did not change colour, as seen in figure 7 and figure 8.

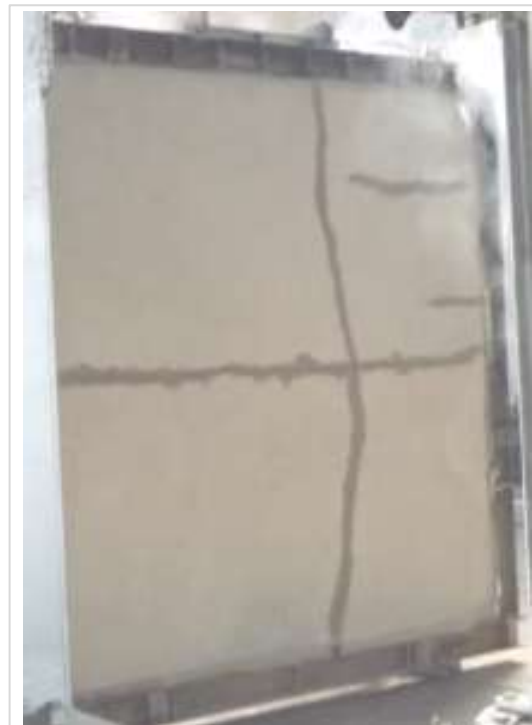
**Figure 8.** Specimen M2 condition after testing on the fire-exposed side. The black line is grouted to cover hair cracks before the burning test
